Application to Refuel the NRU Reactor Past the Guaranteed Subcritical Condition

2010 July 5

NRU Vessel Leak

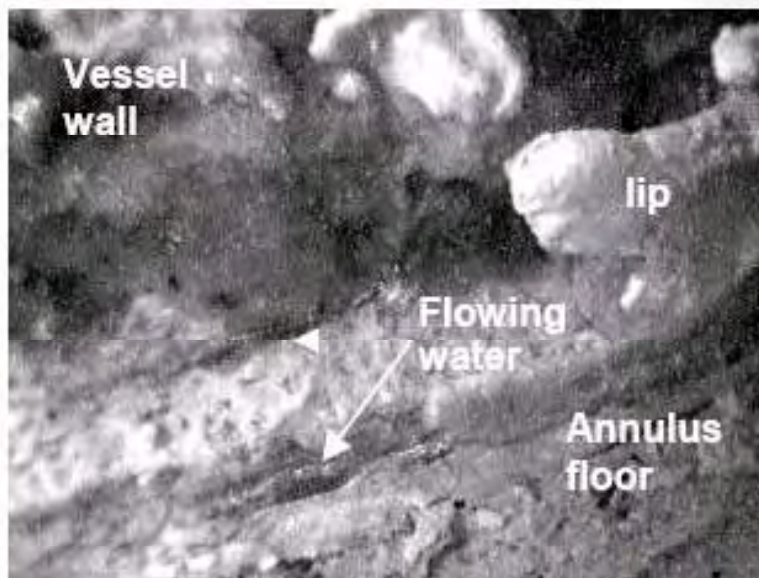
Water seeping through corrosion on outer vessel wall

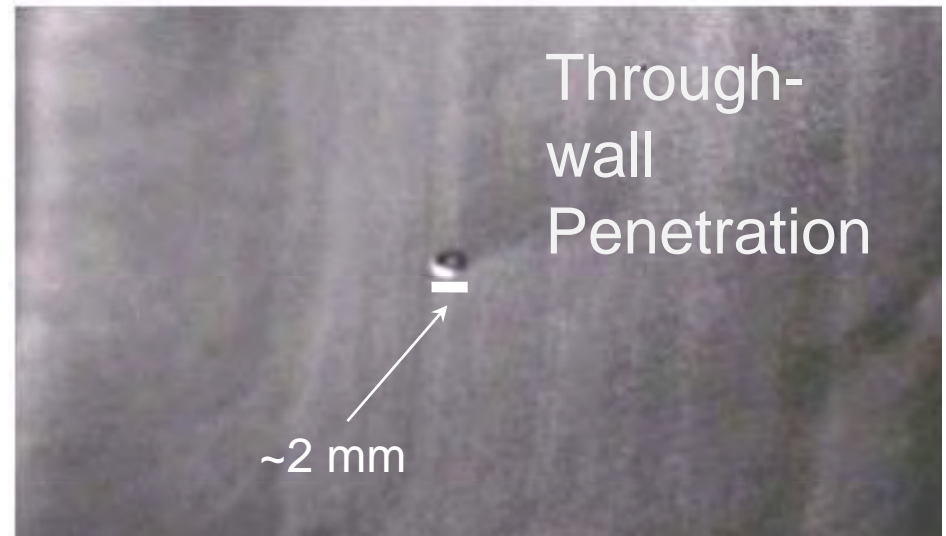
Small hole on inner vessel wall found after surface preparation for welding

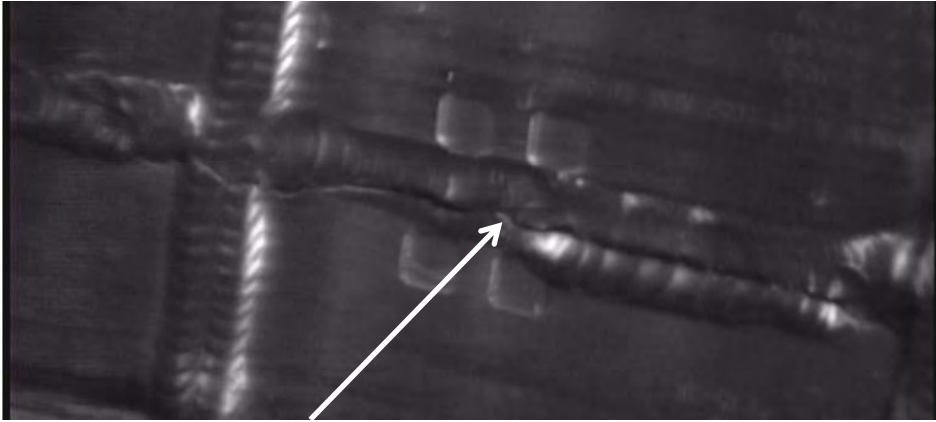
Crack in Repair at JR-13/17

Crack above bottom right plate

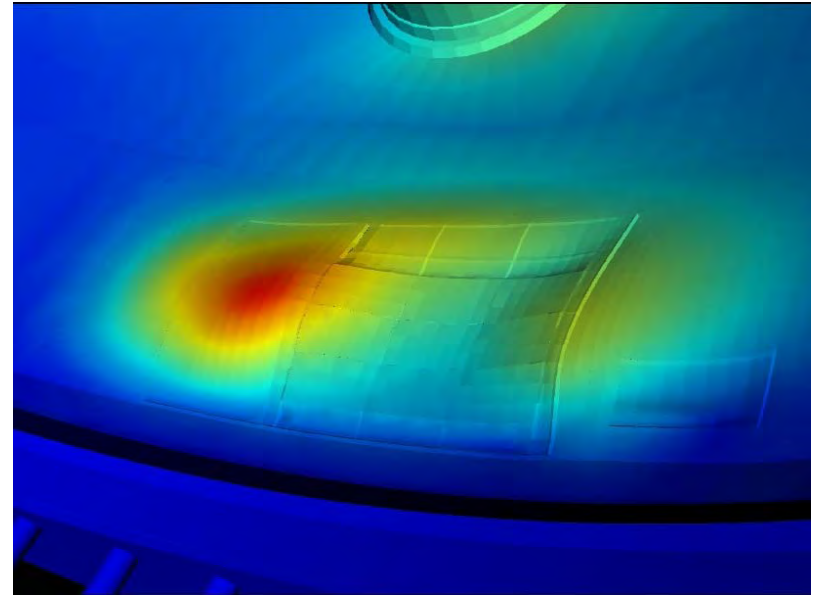
Map of deflection from Welding

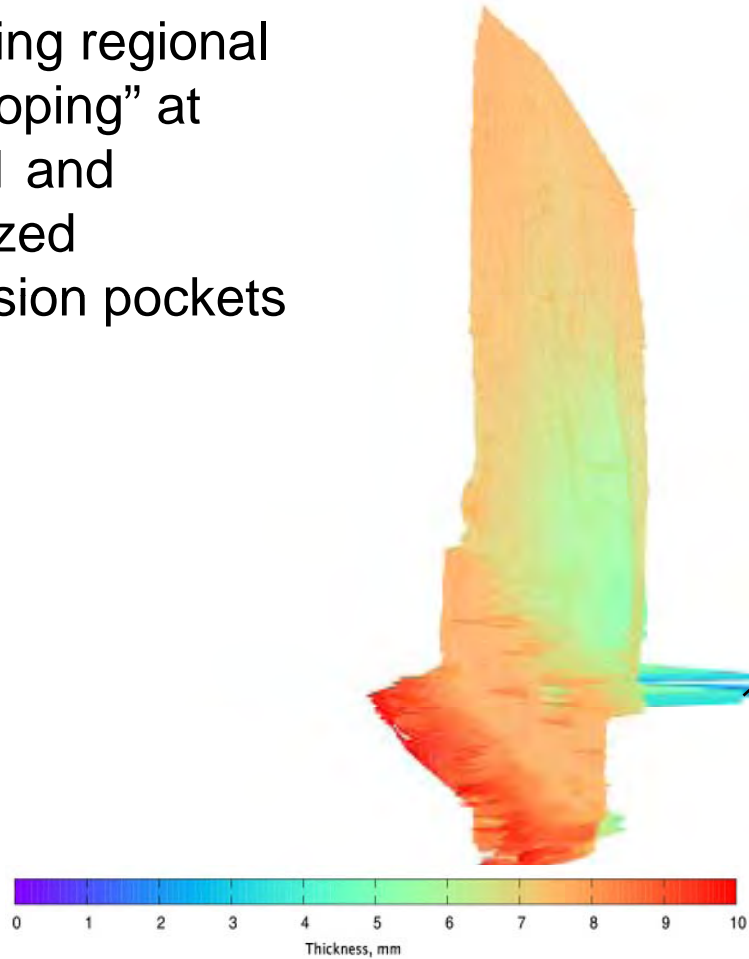
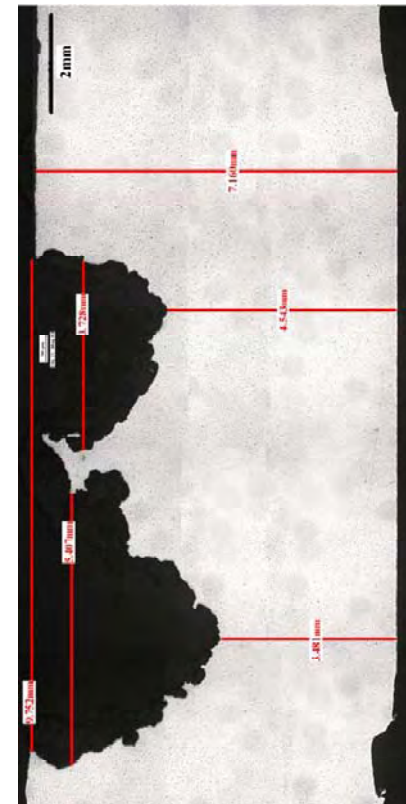
NDE results showing regional “scalping” at JR-41 and localized corrosion pockets

Corrosion mechanism related to formation of nitric acid from air and water leakage into annulus:

- acidic water contacting vessel results in regional wall loss
- local corrosion cell produces corrosion pockets at water line

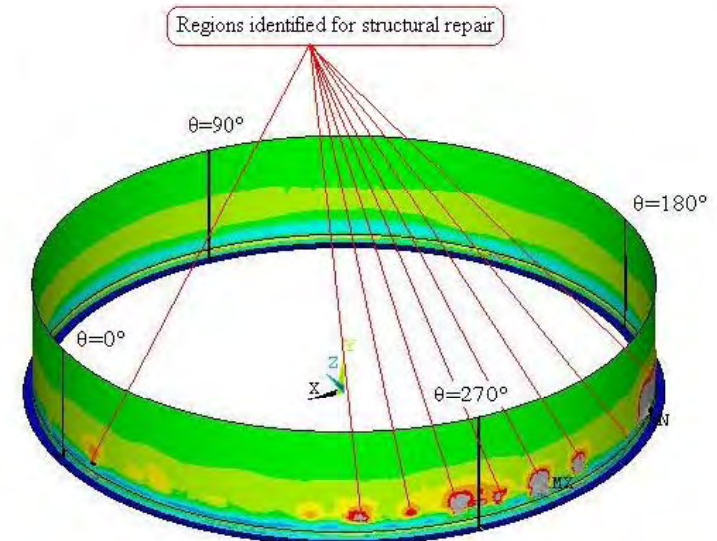
Before and after repair stress field maps
