Application to Refuel the NRU Reactor Past the Guaranteed Subcritical Condition

2010 July 5

NRU Vessel Leak

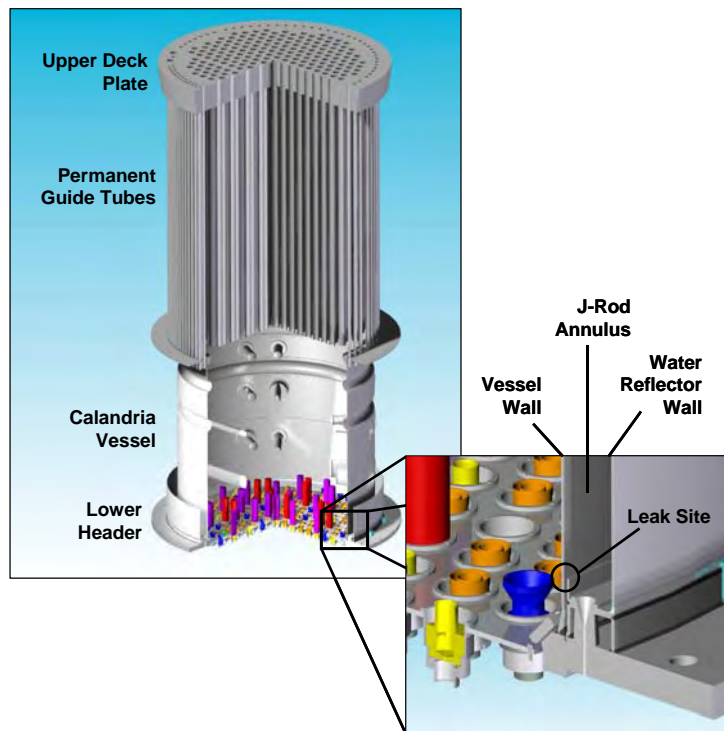
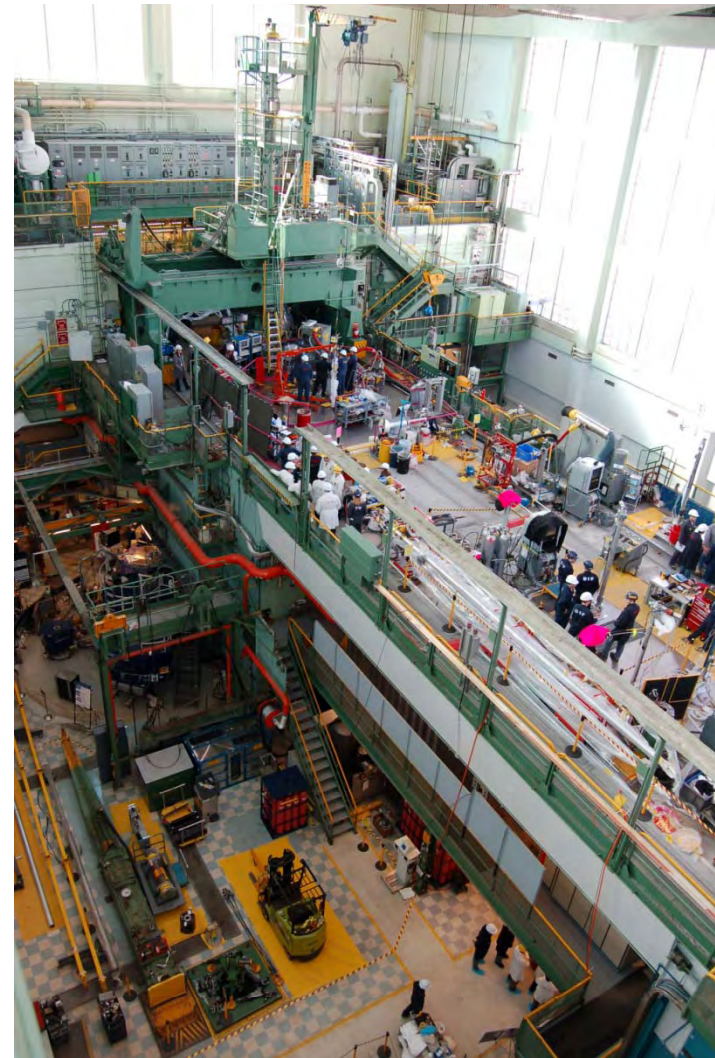
Location of Heavy Water Leak

Accessing the leak site location:

- Apertures of 12cm
- Elevation of 9 meters
- Deck plate diameter 3.7m
- High radiation environment

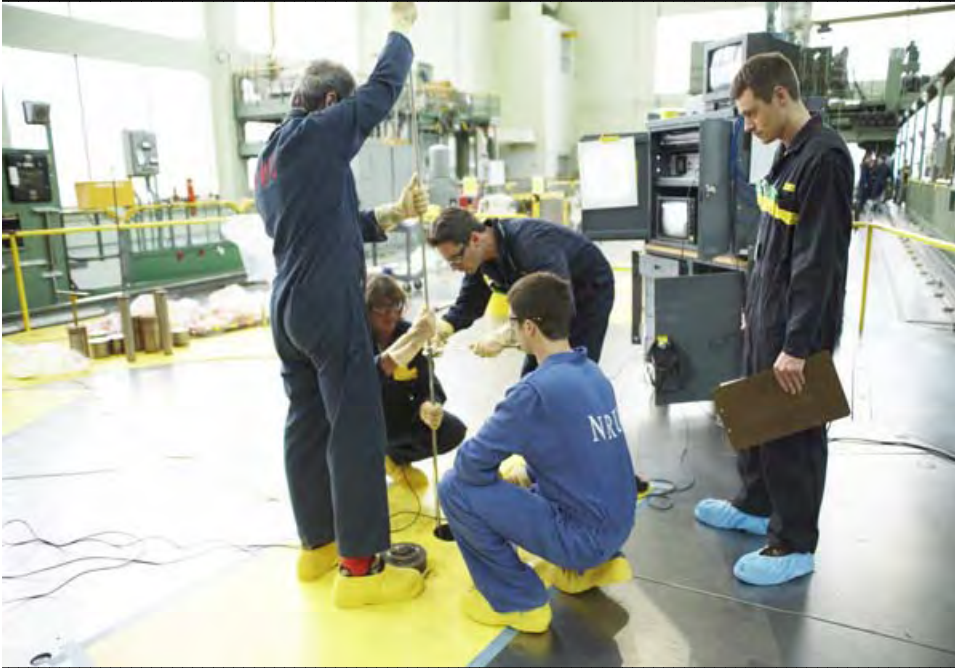
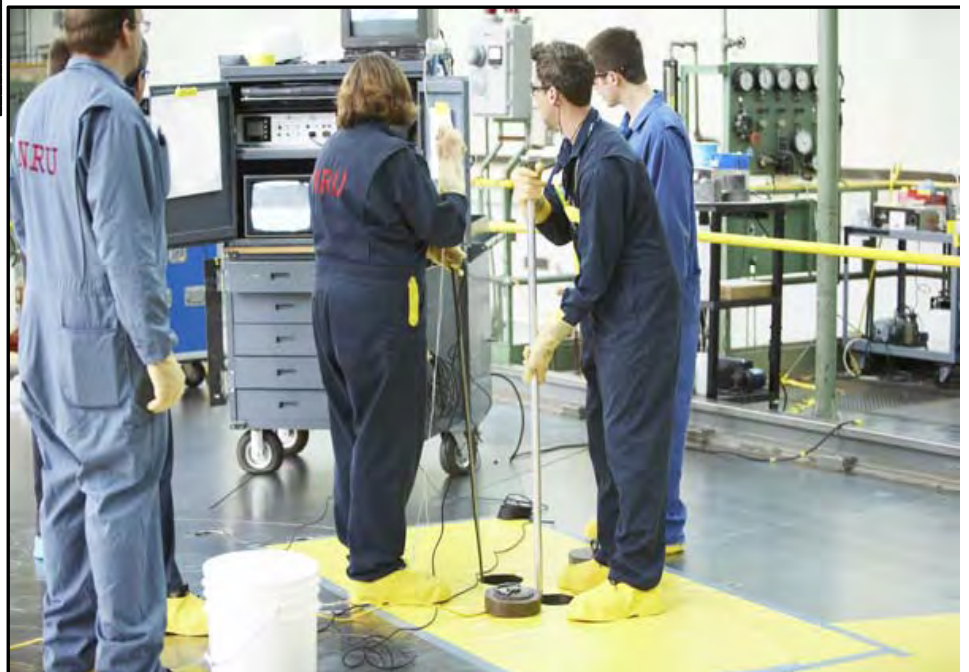
Condition Assessment of Vessel

Non-destructive examination:

- Remote video inspections
- Ultra-sound examination
- Eddy current probes
- Over two million data points
- Four phases

One of largest single NDE inspection campaigns ever carried out in the nuclear industry.

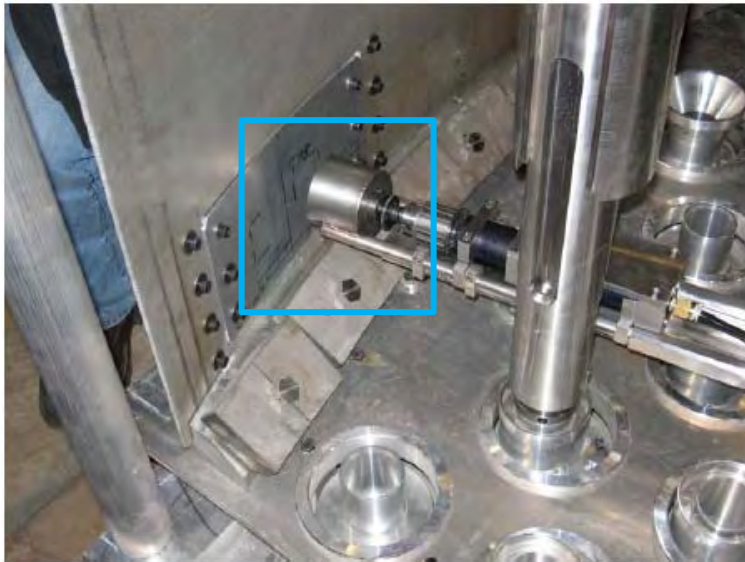
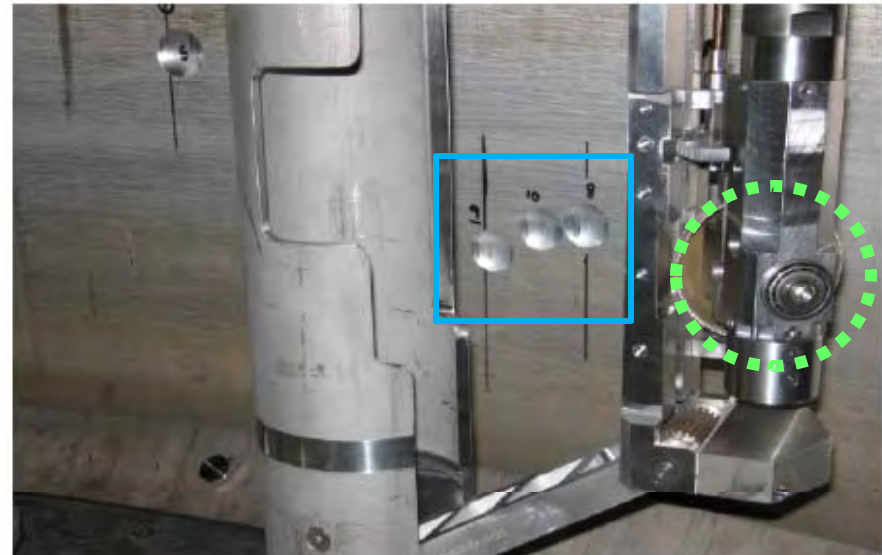
Removing Samples from Vessel Wall

Samples from vessel wall:

- Nature of the corrosion
- Analysis of vessel material
- Final welding qualification & tests

35 years of irradiation has rendered the material unique; there exists no reference in the world to guide development

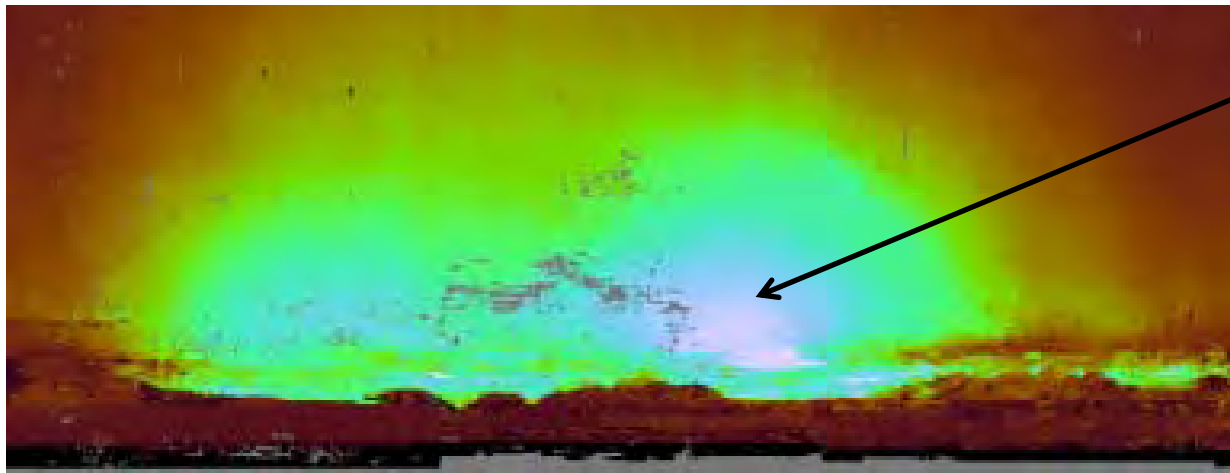
Corrosion Mechanism - Related Aspects

Regional Wall Loss

Localized
Corrosion
Pockets

Corrosion mechanism related to formation of nitric acid from air and water leakage into annulus:

- acidic water contacting vessel results in regional wall loss
- local corrosion cell produces corrosion pockets at water line
